CAPSULE SUMMARY
BA-924
2315 Meredith Road
White Hall, Baltimore County
Circa 1875
Private

Maryland Inventory of Historic Properties Form

Inventory No. BA-924

Name 2315 Meredith Road, White Hall, Baltimore County
Continuation Sheet

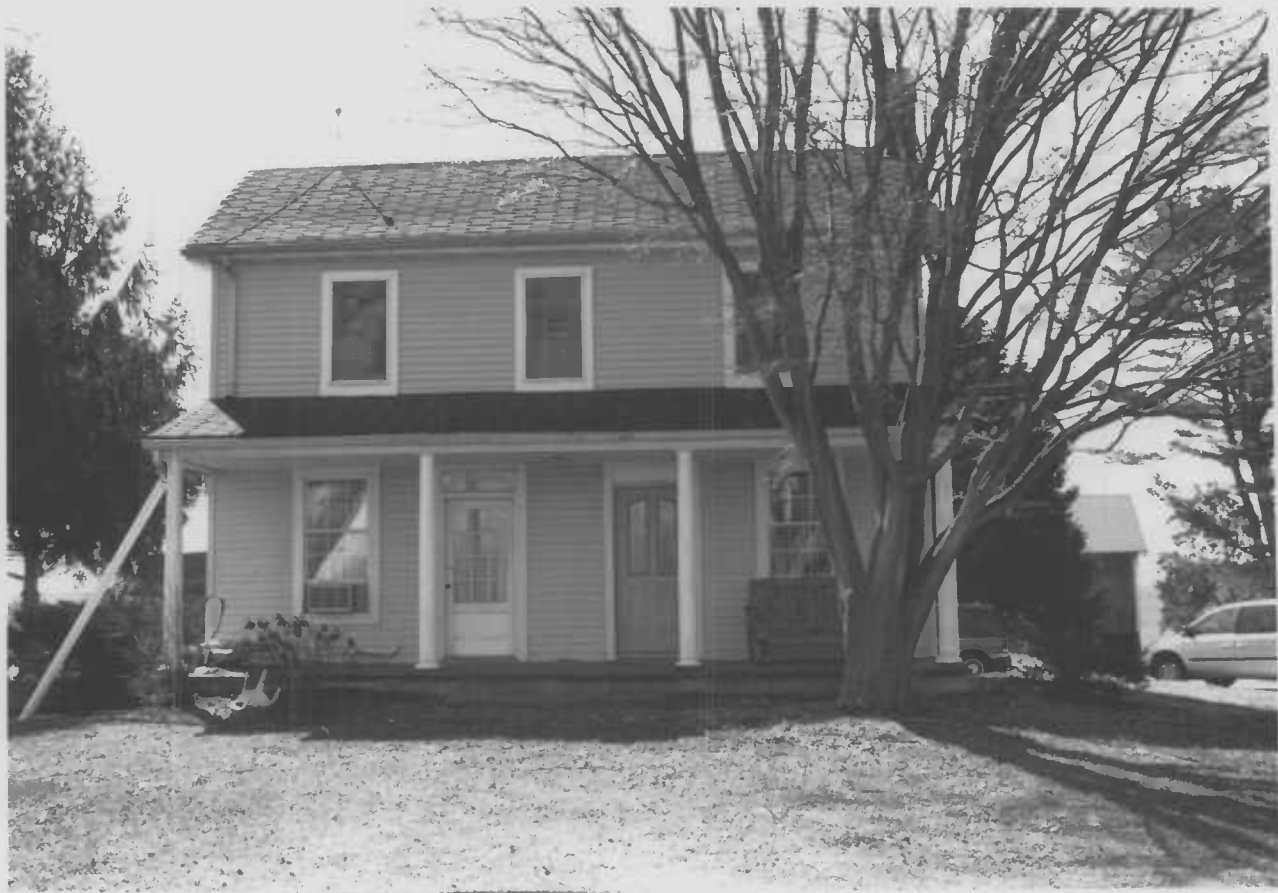
1 OF 7

MAIN HOUSE, NORTHEAST ELEVATION

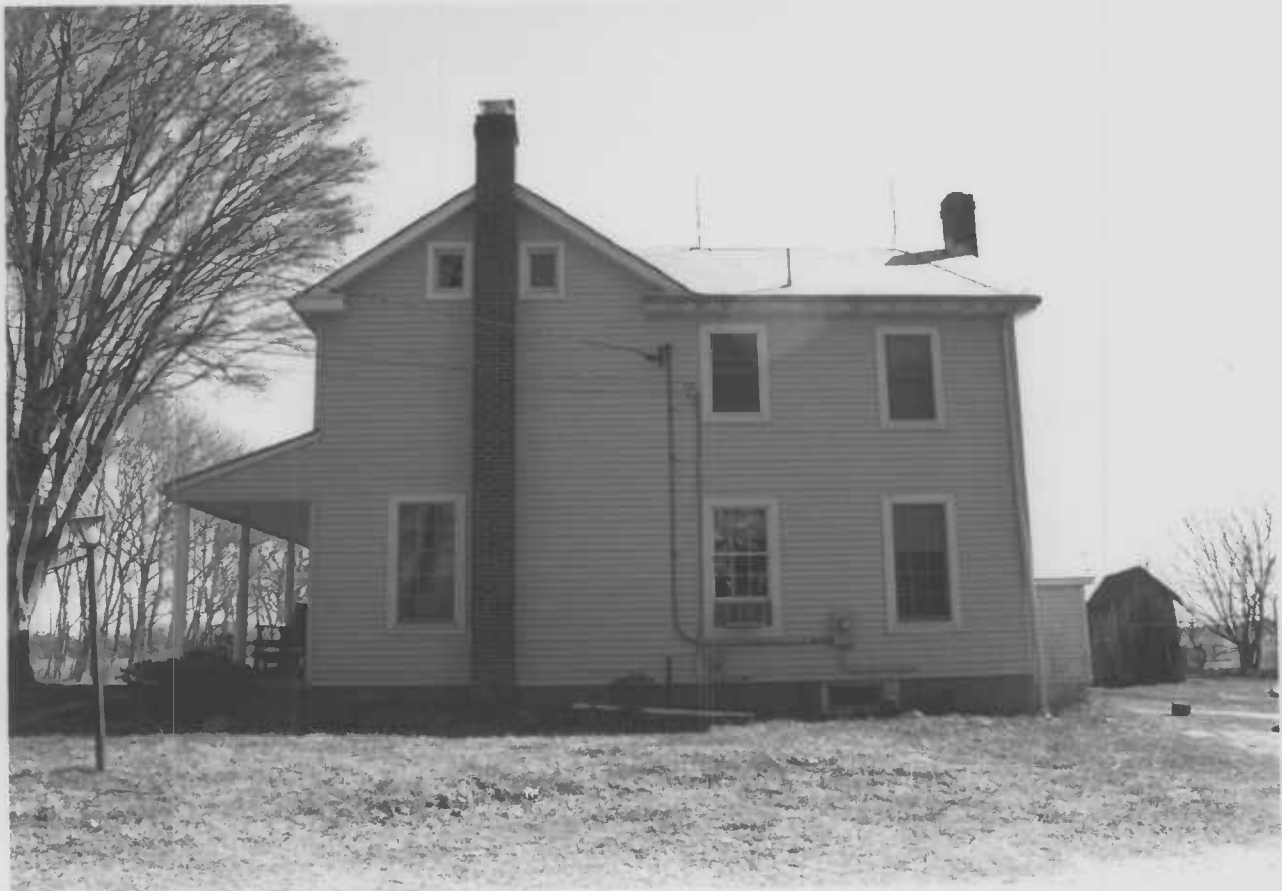
2 of 7

MAIN HOUSE, NORTHWEST ELEVATION

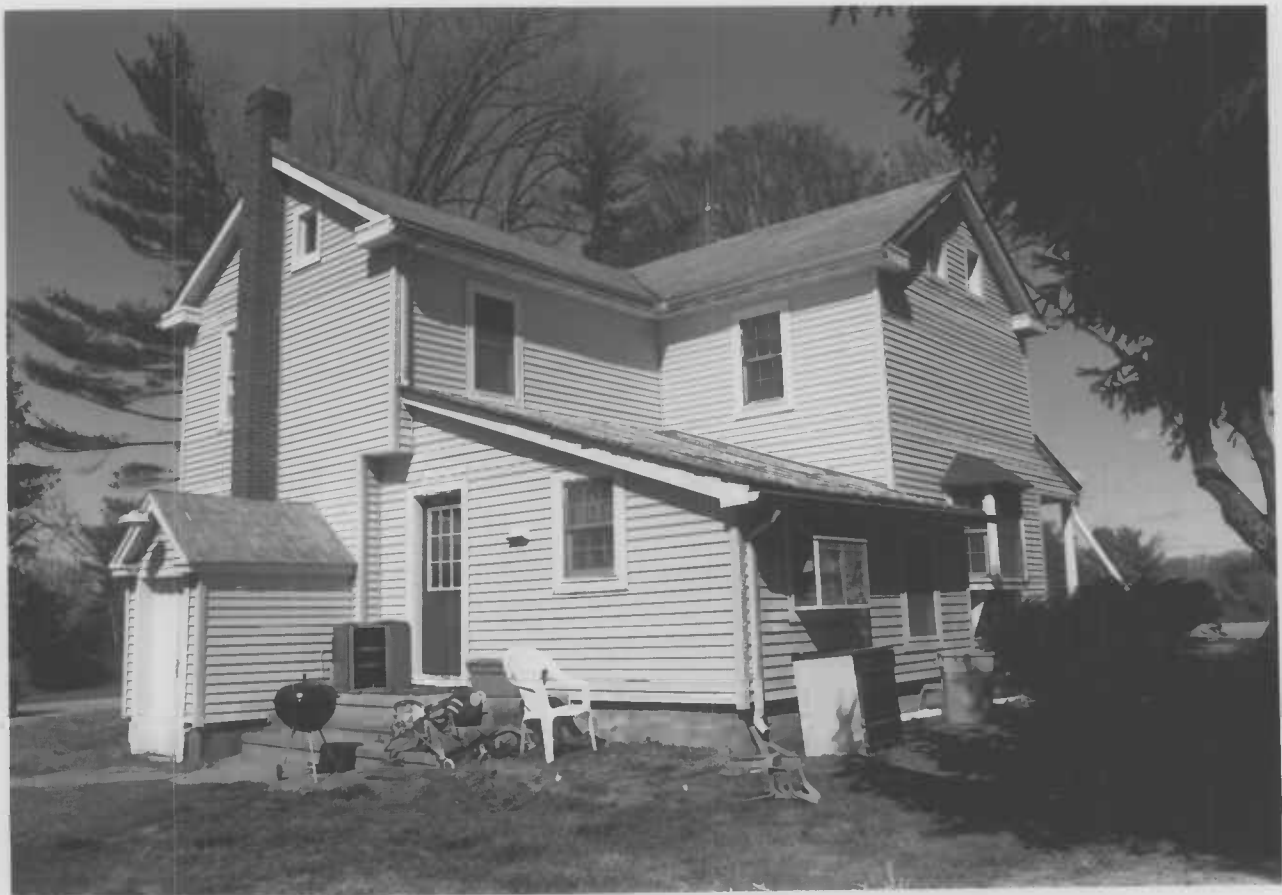
3 OF 7

MAIN HOUSE, SOUTH CORNER

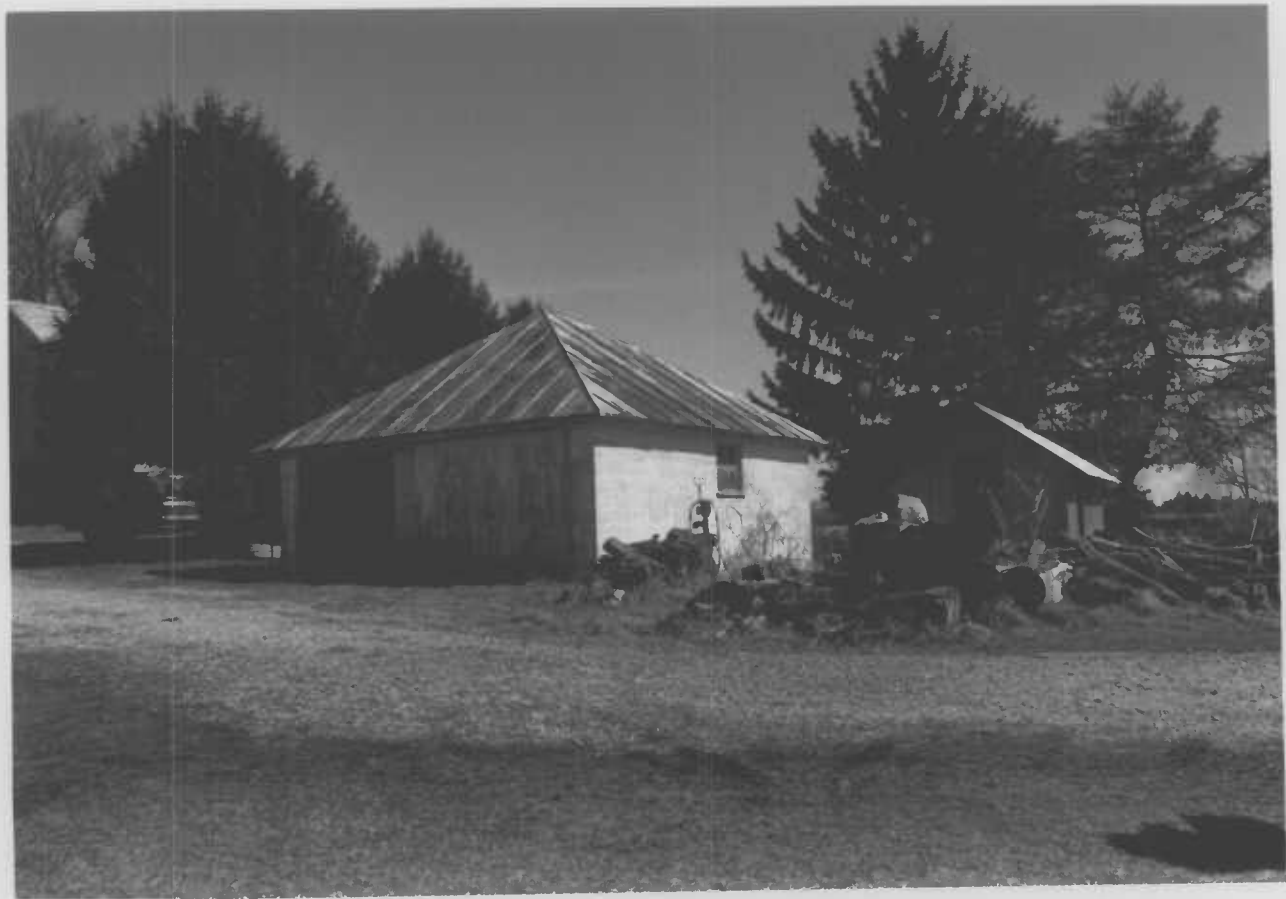
4 OF 7

A circa 1940s paneled concrete block garage is located to the rear of the house. The façade is pierced with a two-leaf vertical board sliding door. It is capped with a hipped roof clad with standing-seam metal.

Next to the garage is a one-story high one bay wide circa 1950 wood frame shed. The walls and front gable roof are clad with corrugated sheet metal. The one-leaf door on the front is missing.

GARAGE AND SHED, VIEW LOOKING NORTHEAST

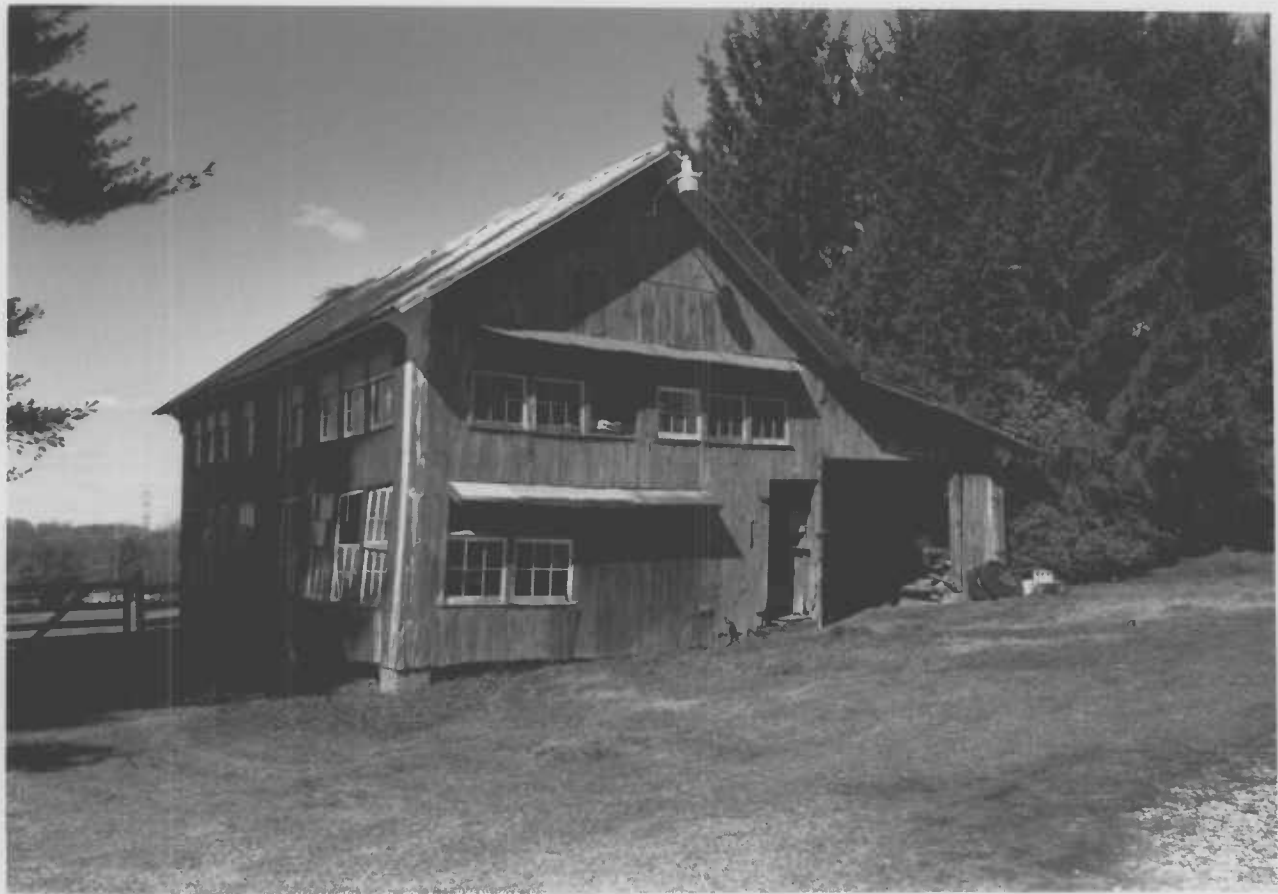
5 OF 7

A circa 1930 dairy bank-barn standing one-and-a-half stories high sits on a solid parged foundation and is clad with vertical boards. The façade has several open bays at the ground level and a two-leaf sliding vertical board door on the upper story. It is capped with a gambrel roof covered with corrugated sheet metal. A concrete-stave silo is attached to the barn.

BANK BARN, EAST ELEVATION

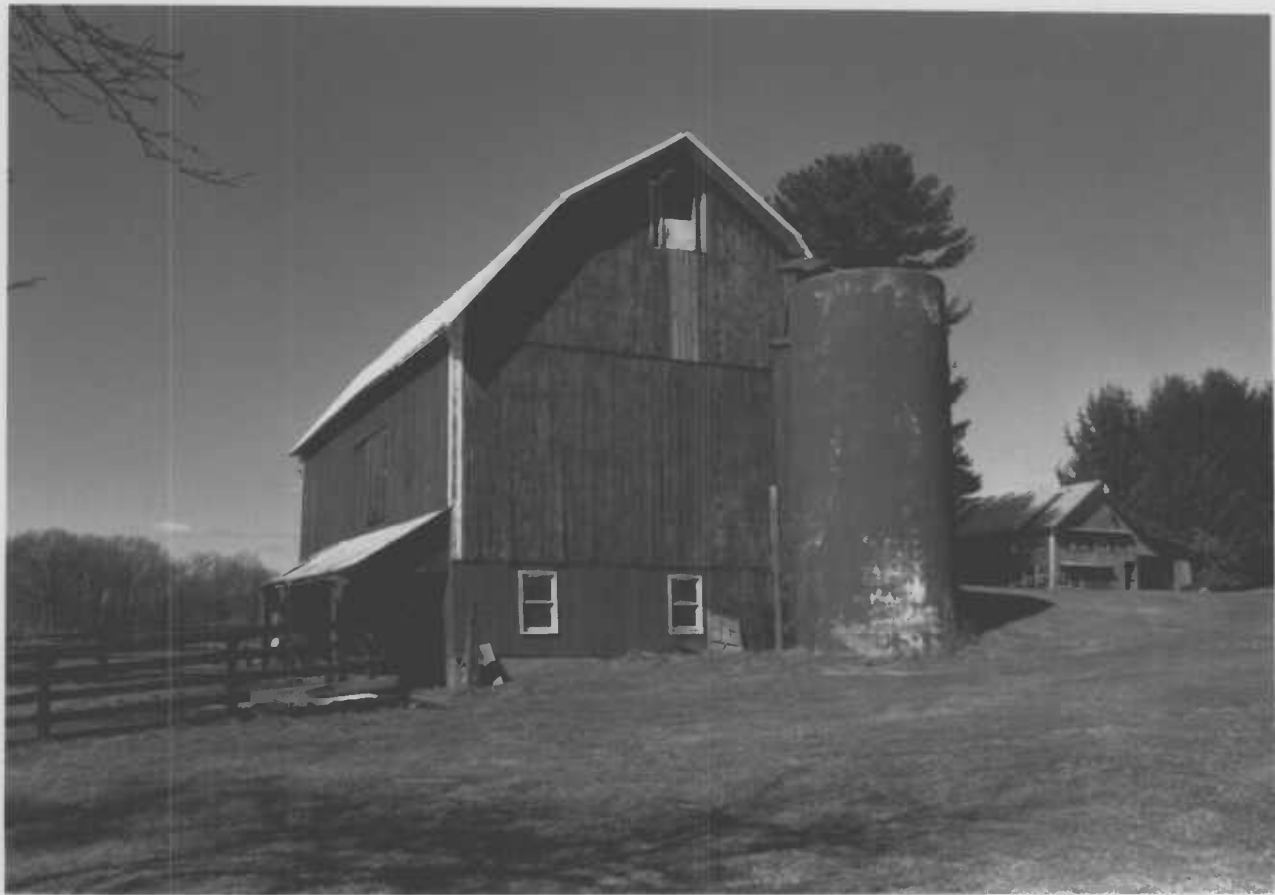
6 OF 7

To the southwest of the main house is a circa 1900 two-story wood frame barn, possibly a dairy barn suggested by the numerous windows on the front and side elevations. It stands on a concrete-block pier replacement foundation and is clad with vertical boards. The southeast elevation shows 8 6/6 double-hung wood sash windows and the side elevation shows 16 6/6 double-hung wood sash windows. The southeast elevation has a single-leaf door opening which is missing the door. The building is capped by a front gable roof with overhanging eaves and clad with corrugated sheet metal. The northeast elevation has a one-story shed roof addition with a large open bay.

BARN AND BANK BARN, EAST CORNER

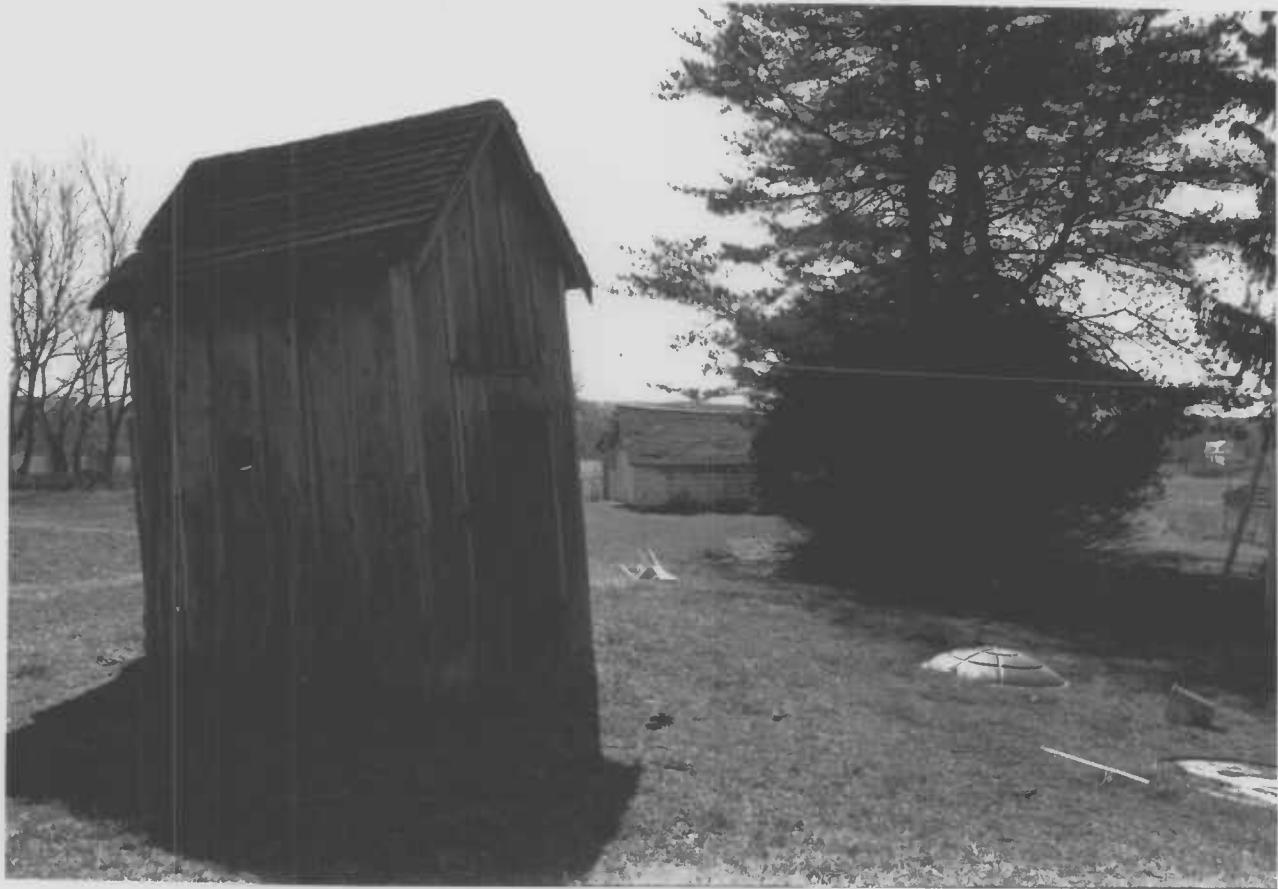
7 OF 7

There are six historic outbuildings associated with this property. A circa 1920 smokehouse is one bay wide and one story high and is wood frame covered with board-and-batten siding. No foundation is visible, and the single-leaf door is of vertical boards. The asphalt shingle covered front-gable roof is steeply pitched and features exposed roof rafters.

Finally, furthest away from the main house to the rear is a circa 1920 chicken coop constructed of concrete blocks. It has a front gable roof covered both with asphalt shingles and corrugated sheet metal. It is pierced

with two 6-light wood awning windows and a single-leaf vertical board door. The overhanging eaves of the roof feature exposed roof rafters.

SMOKEHOUSE AND CHICKEN COOP, VIEW LOOKING SOUTHWEST
